GMI Expo 2103

Management of Flashing Losses from Condensate Tanks at Compressor Stations

David Picard (Clearstone Engineering Ltd)

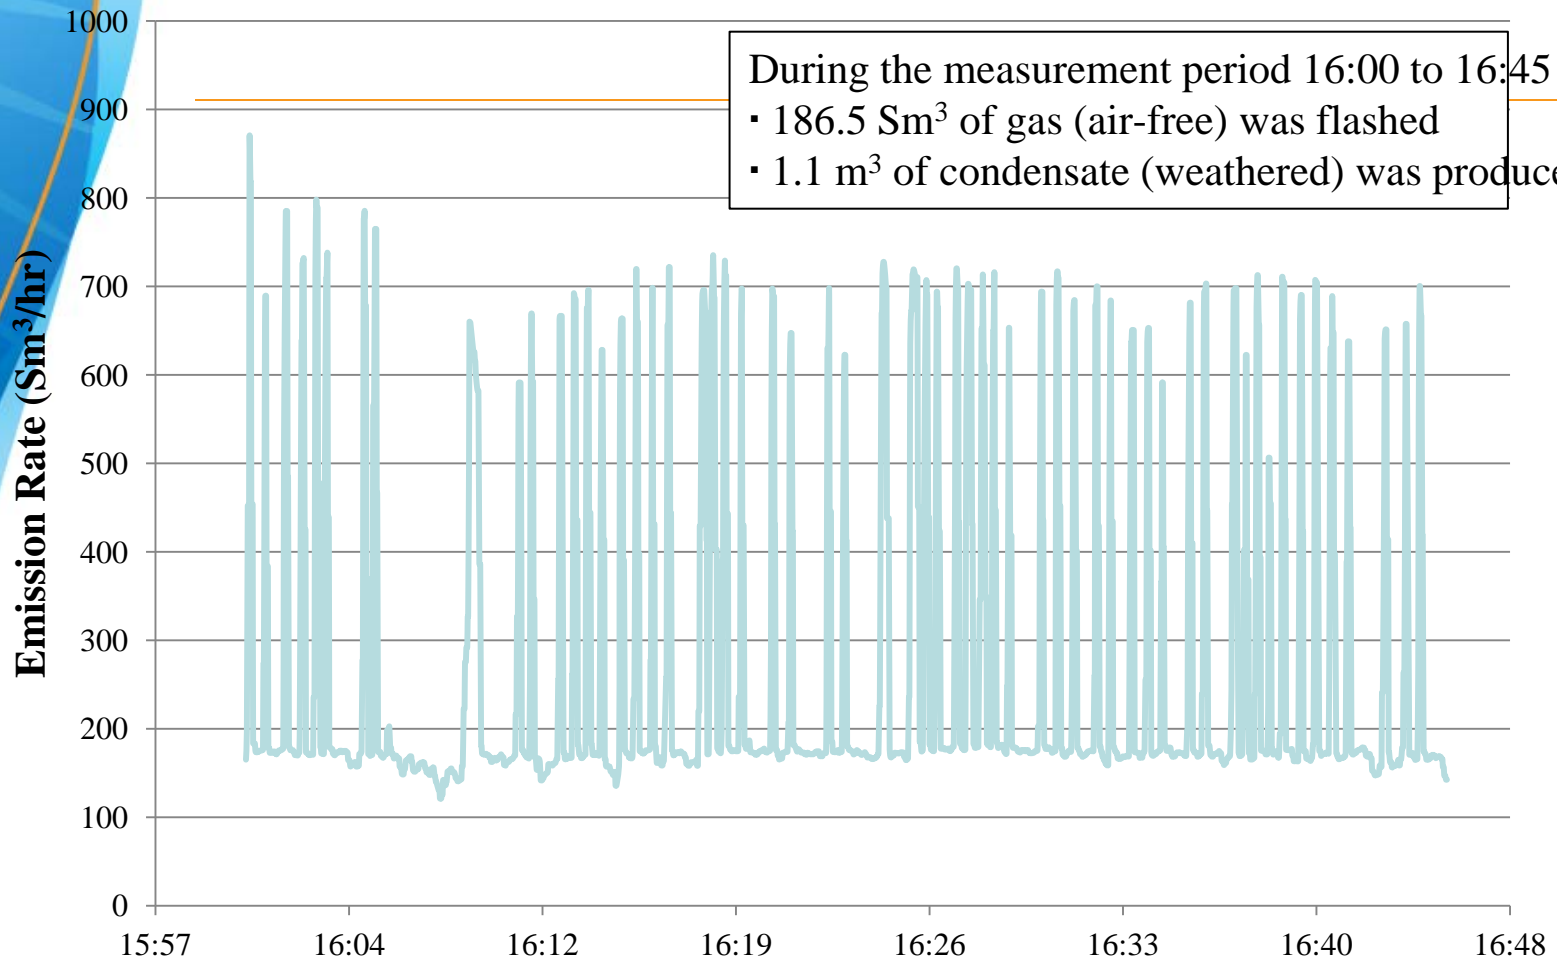
7-30 Condensate Tank Flashing Losses

During the measurement period 16:00 to 16:45

- 186.5 Sm^3 of gas (air-free) was flashed
- 1.1 m^3 of condensate (weathered) was produced

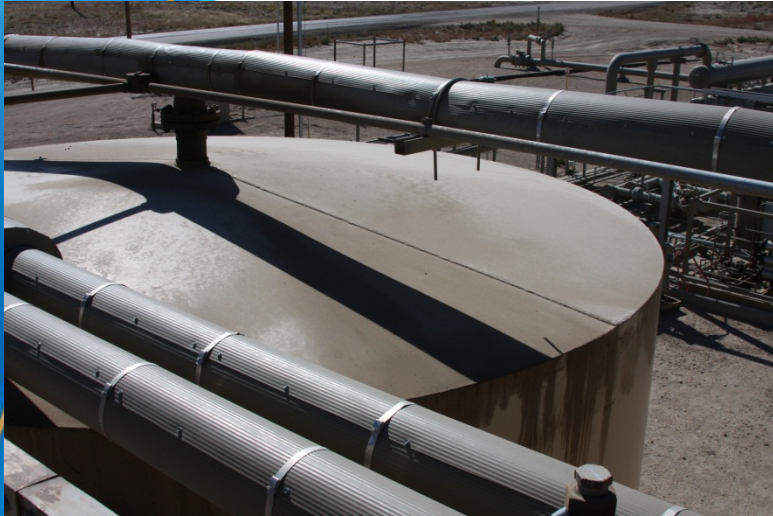
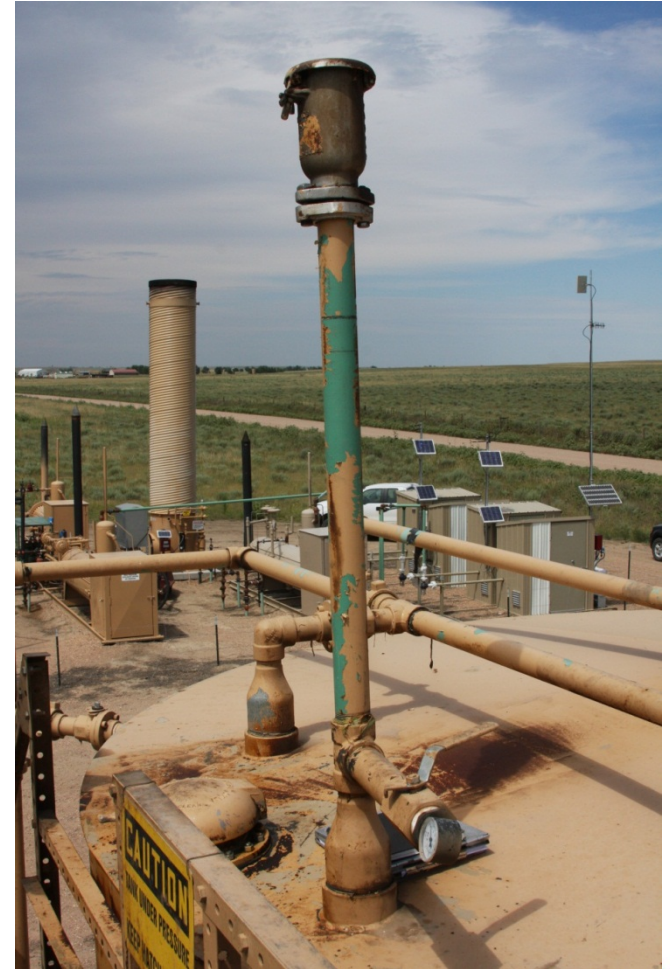
Incorrect Sizing of Vapour Control Systems

- Standard designs commonly applied at production facilities with limited consideration of site-specific conditions:
 - Frequency and duration of separator dumping events.
