*In-Seam Directional Drilling
and Gas Drainage
Demonstration Project –
Baijigou, PR China*

*Frank Hungerford
Valley Longwall Drilling*

Baijigou Service Project

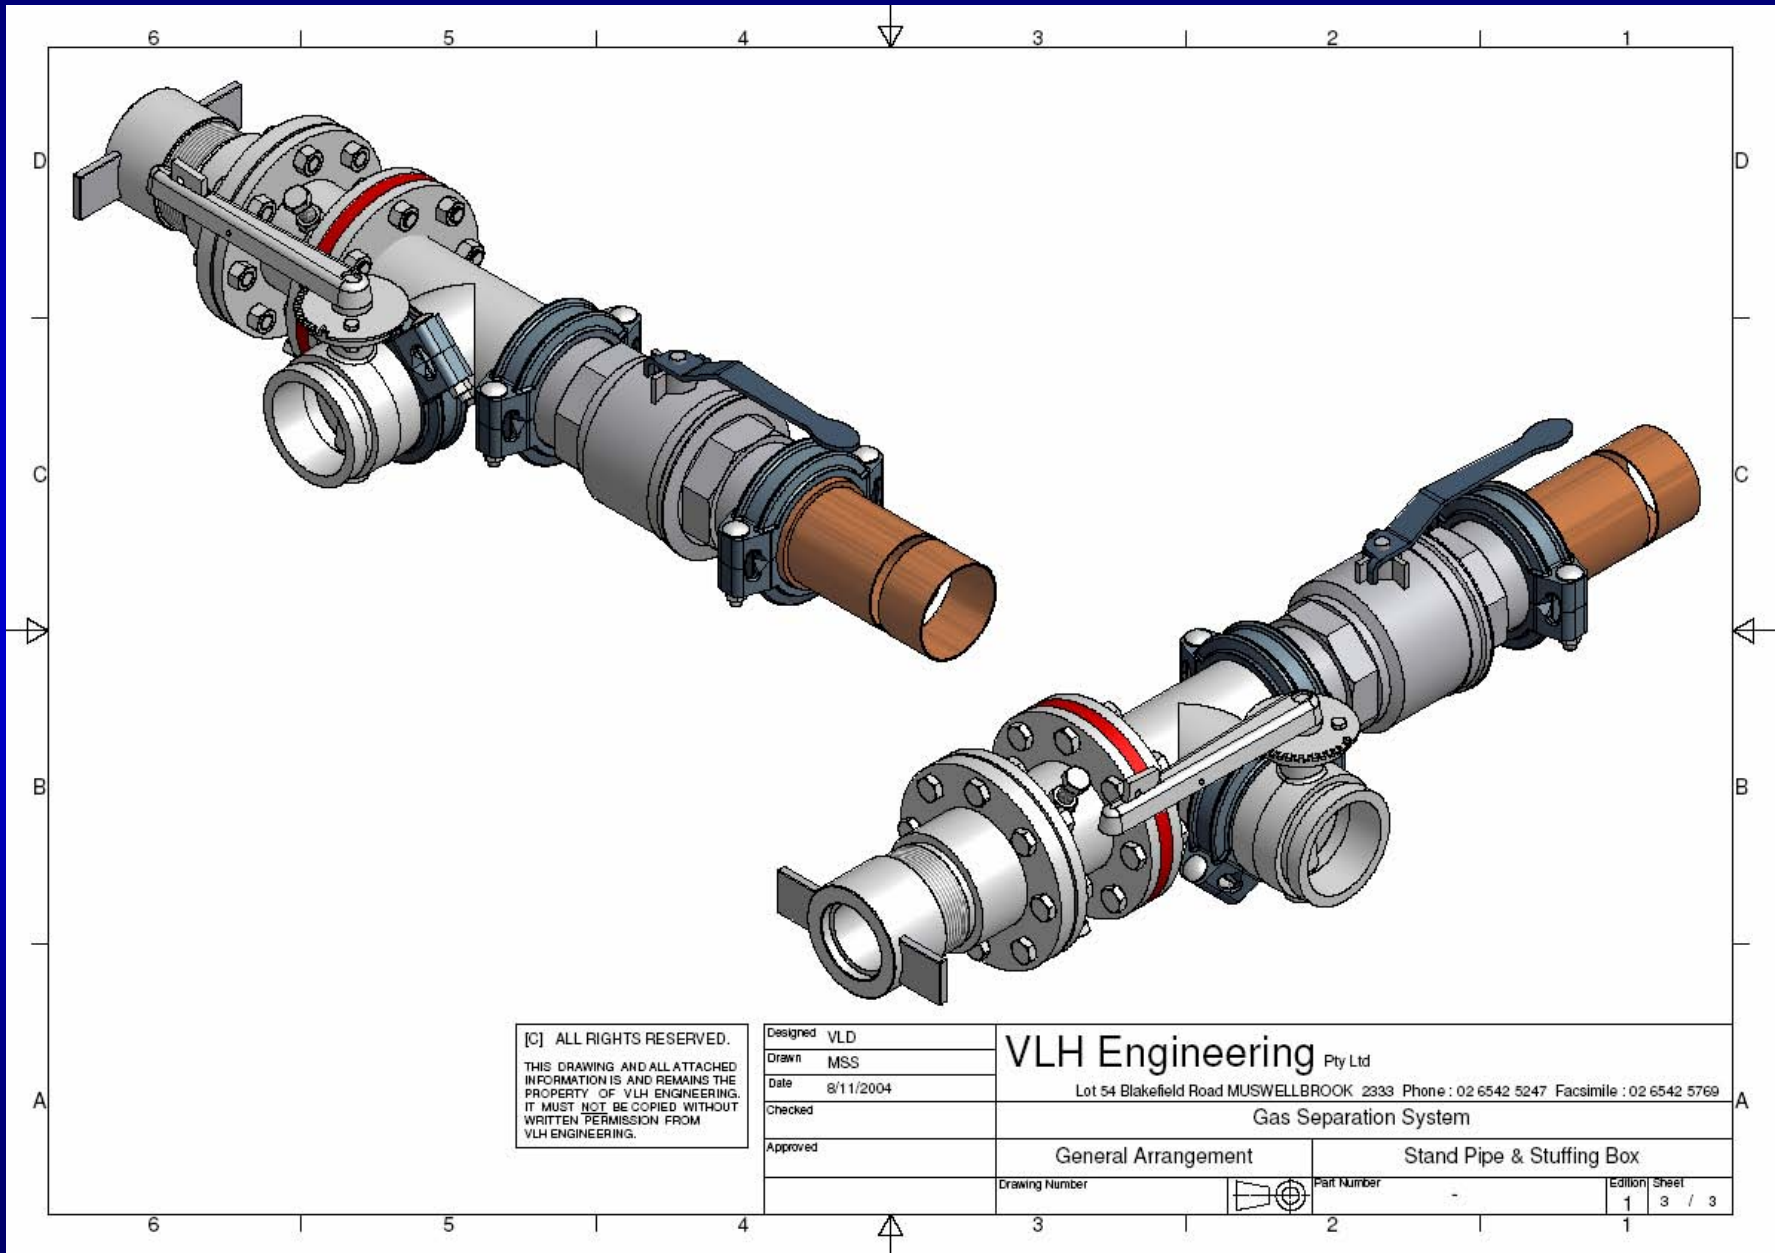
Borehole Collar – Standpipe Fittings

Gas Separation System
 General Arrangement Stand Pipe & Stuffing Box

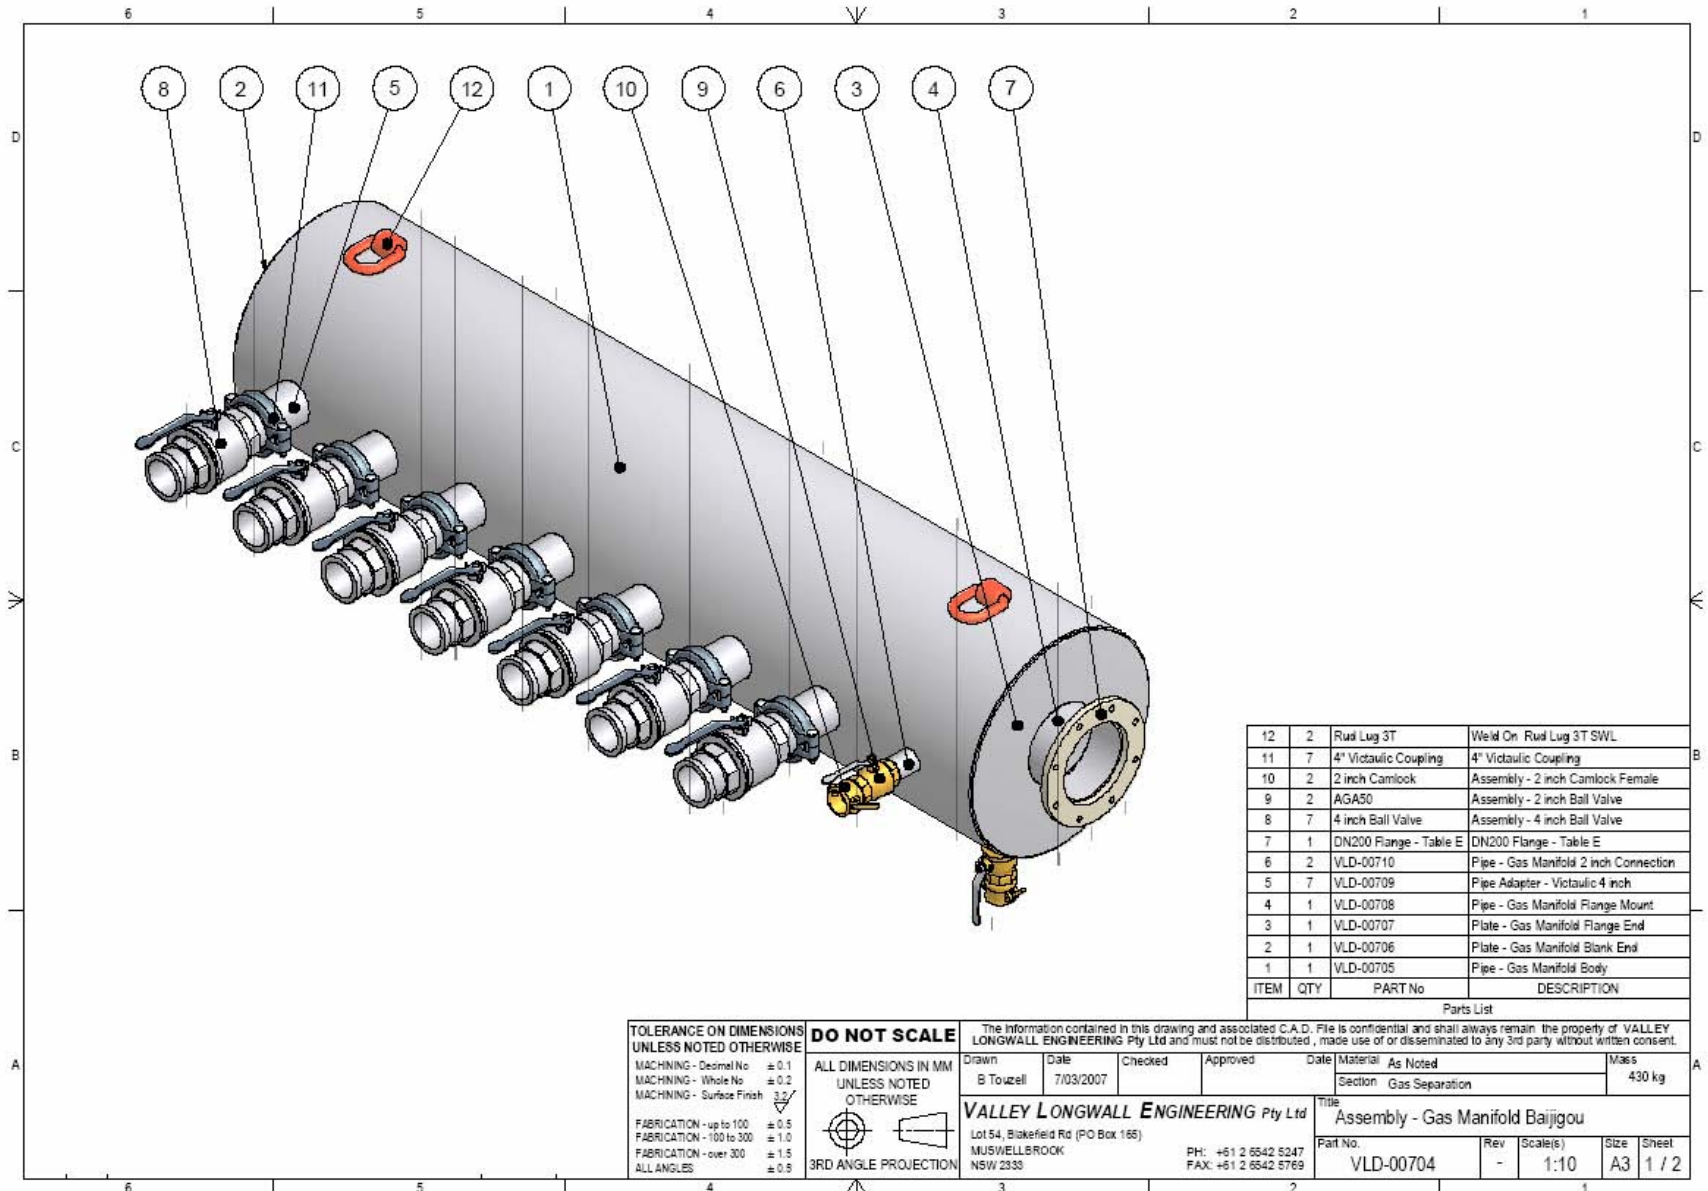
Gas Manifold – Drill Site

Title: **Assembly - Gas Manifold Baijigou**

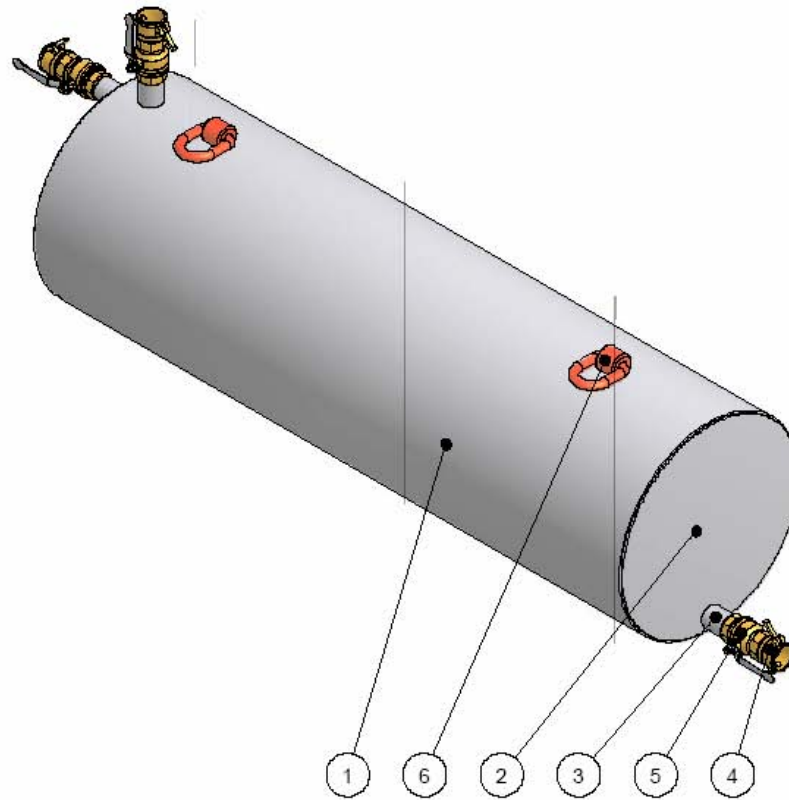
Water Trap – Drill Site

VALLEY LONGWALL ENGINEERING Pty Ltd		Title	
Lot 54, Blakefield Rd (PO Box 165) MUSWELLSBROOK NSW 2333		Assembly - Water Trap Baijigou	
Part No.	Rev	Scale(s)	Size
VLD-00711	-	1:10	A3
			Sheet
			1 / 2

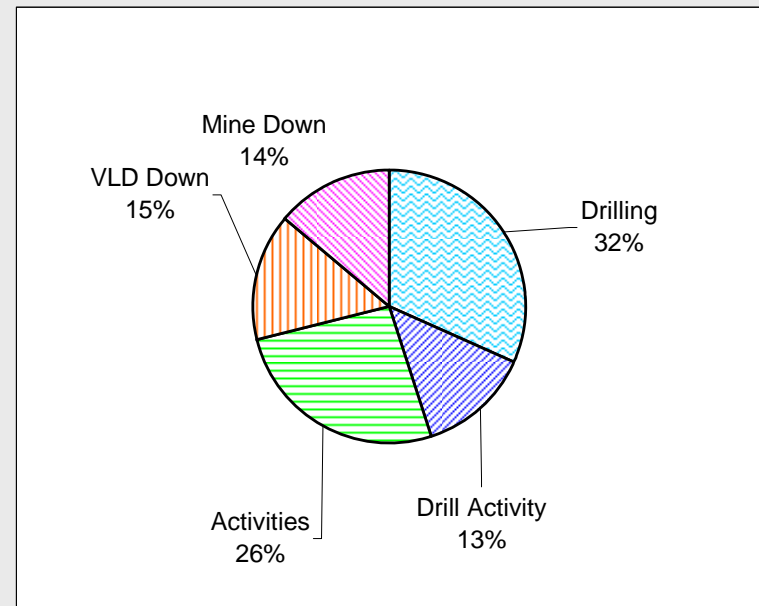
PROJECT DRILLING PERFORMANCE

Activity Group	Status	Minutes	%
Drilling	D	41465	31.8
Drill Activity	L	17330	13.3
Activities	A	34055	26.1
VLD Down	V	19445	14.9
Mine Down	M	18195	13.9
